NONFATAL COAL OUTBURST

Virginia Pocahontas No. 3 Mine (ID No. 44-01520)  
ISLAND CREEK COAL COMPANY  
Vansant, Buchanan County, Virginia

January 12, 1988

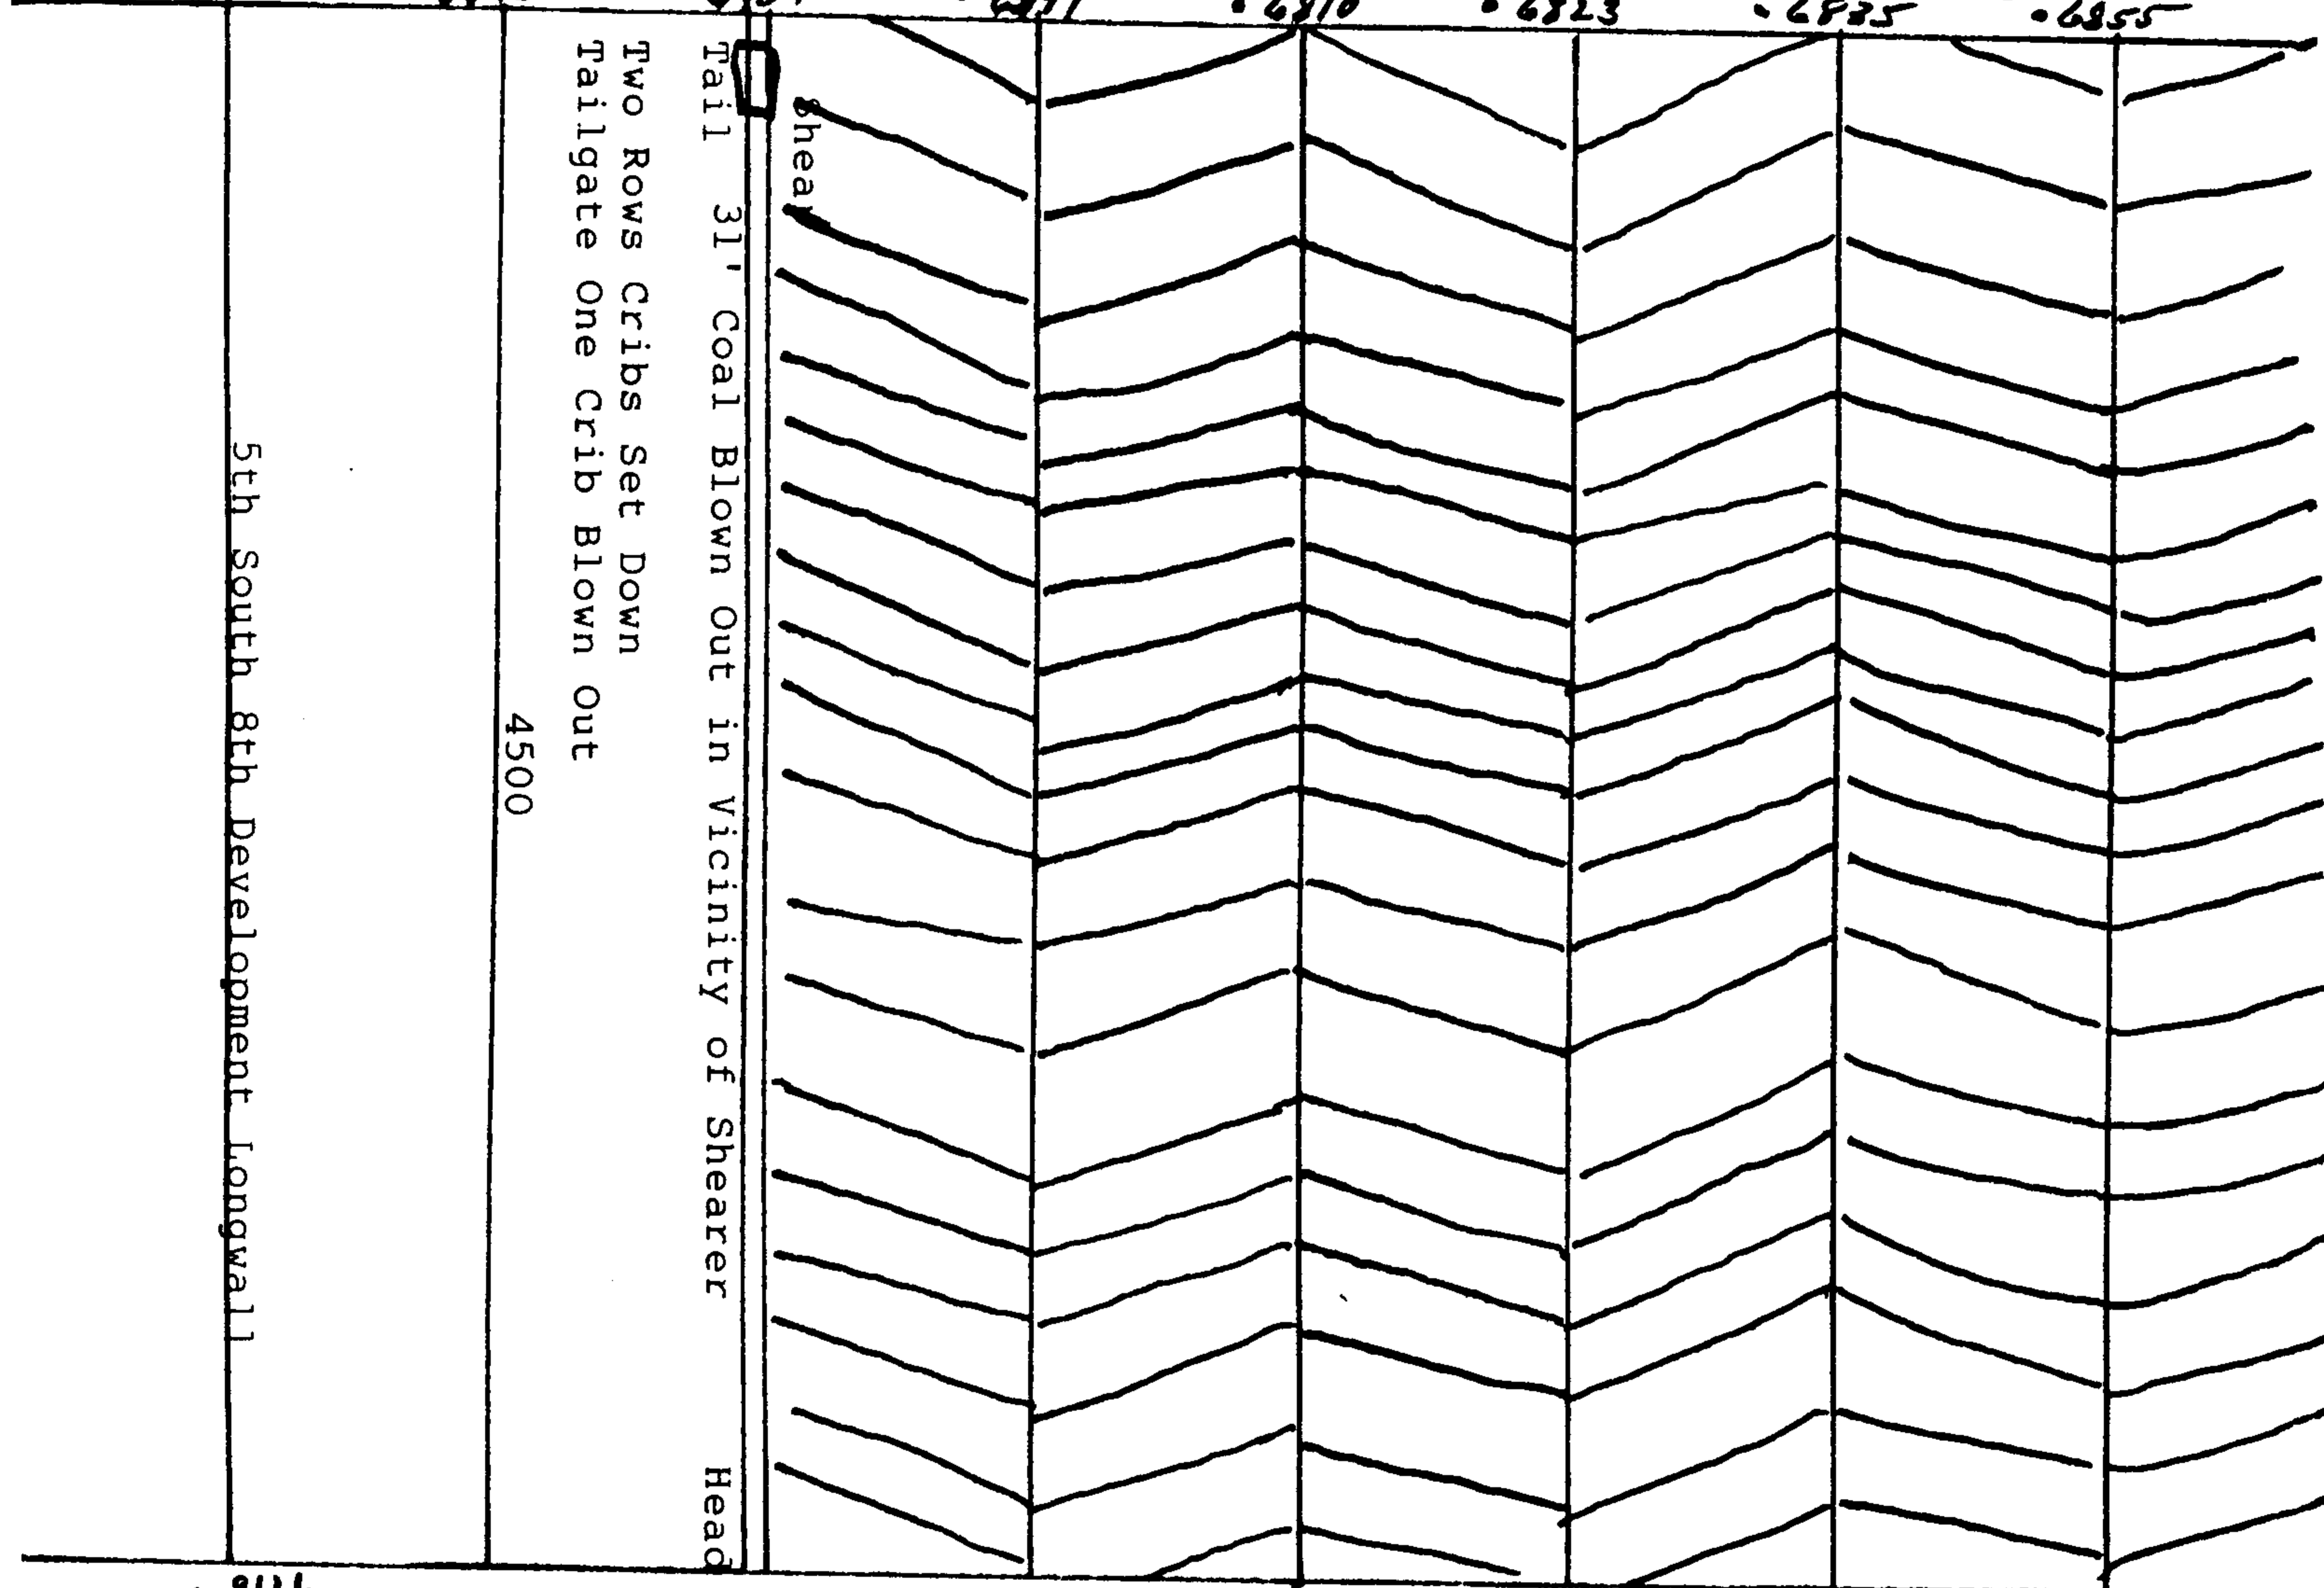
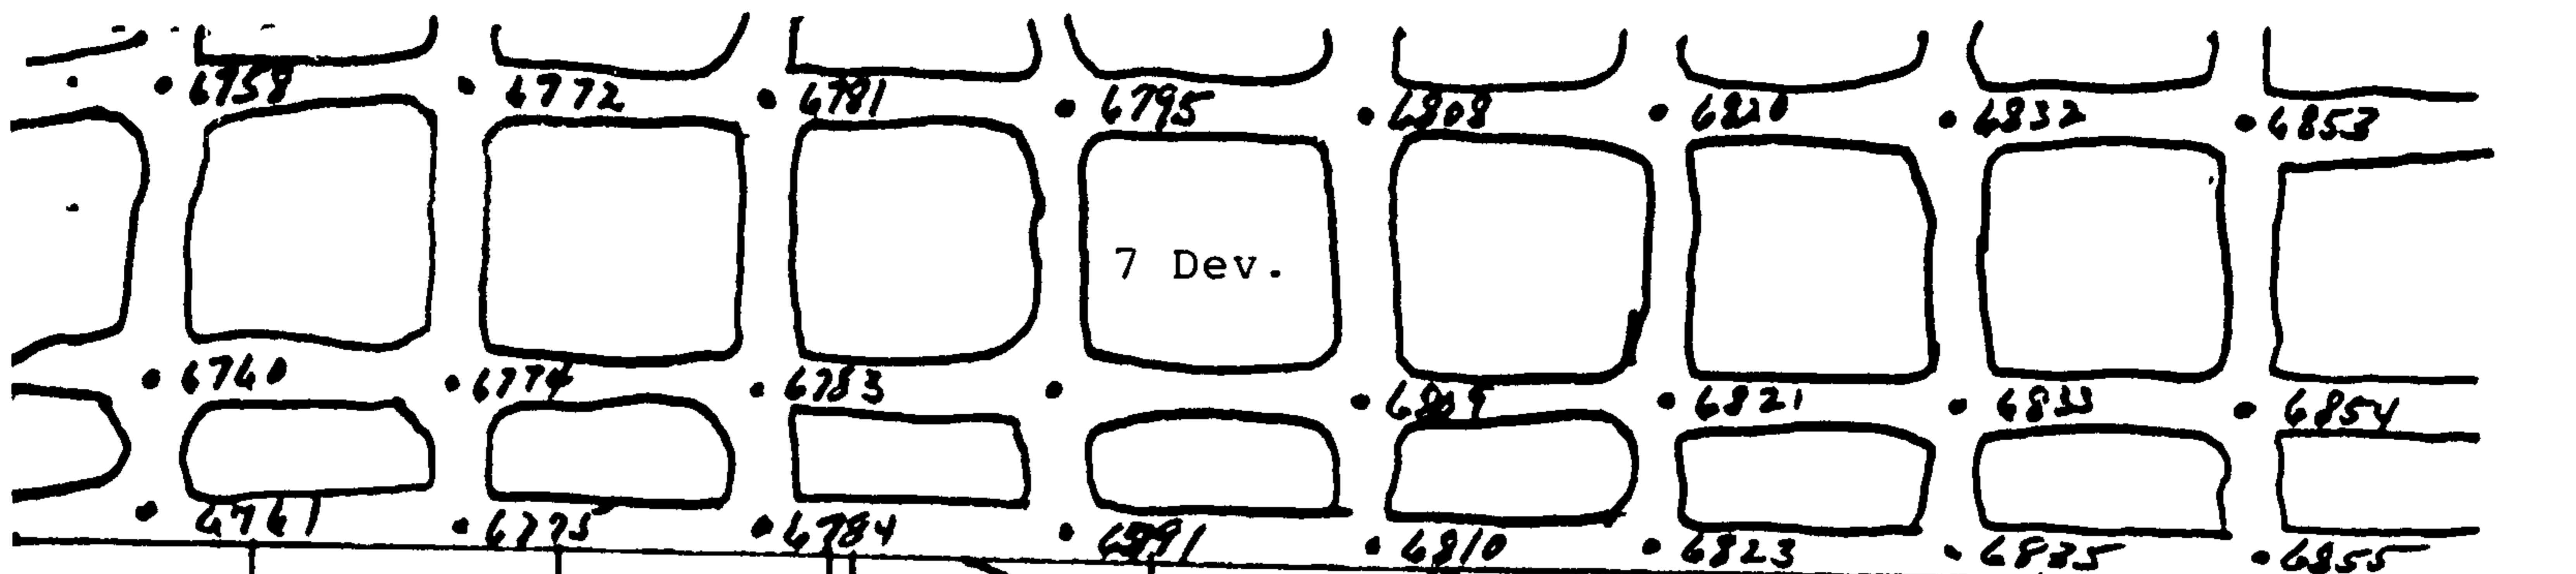
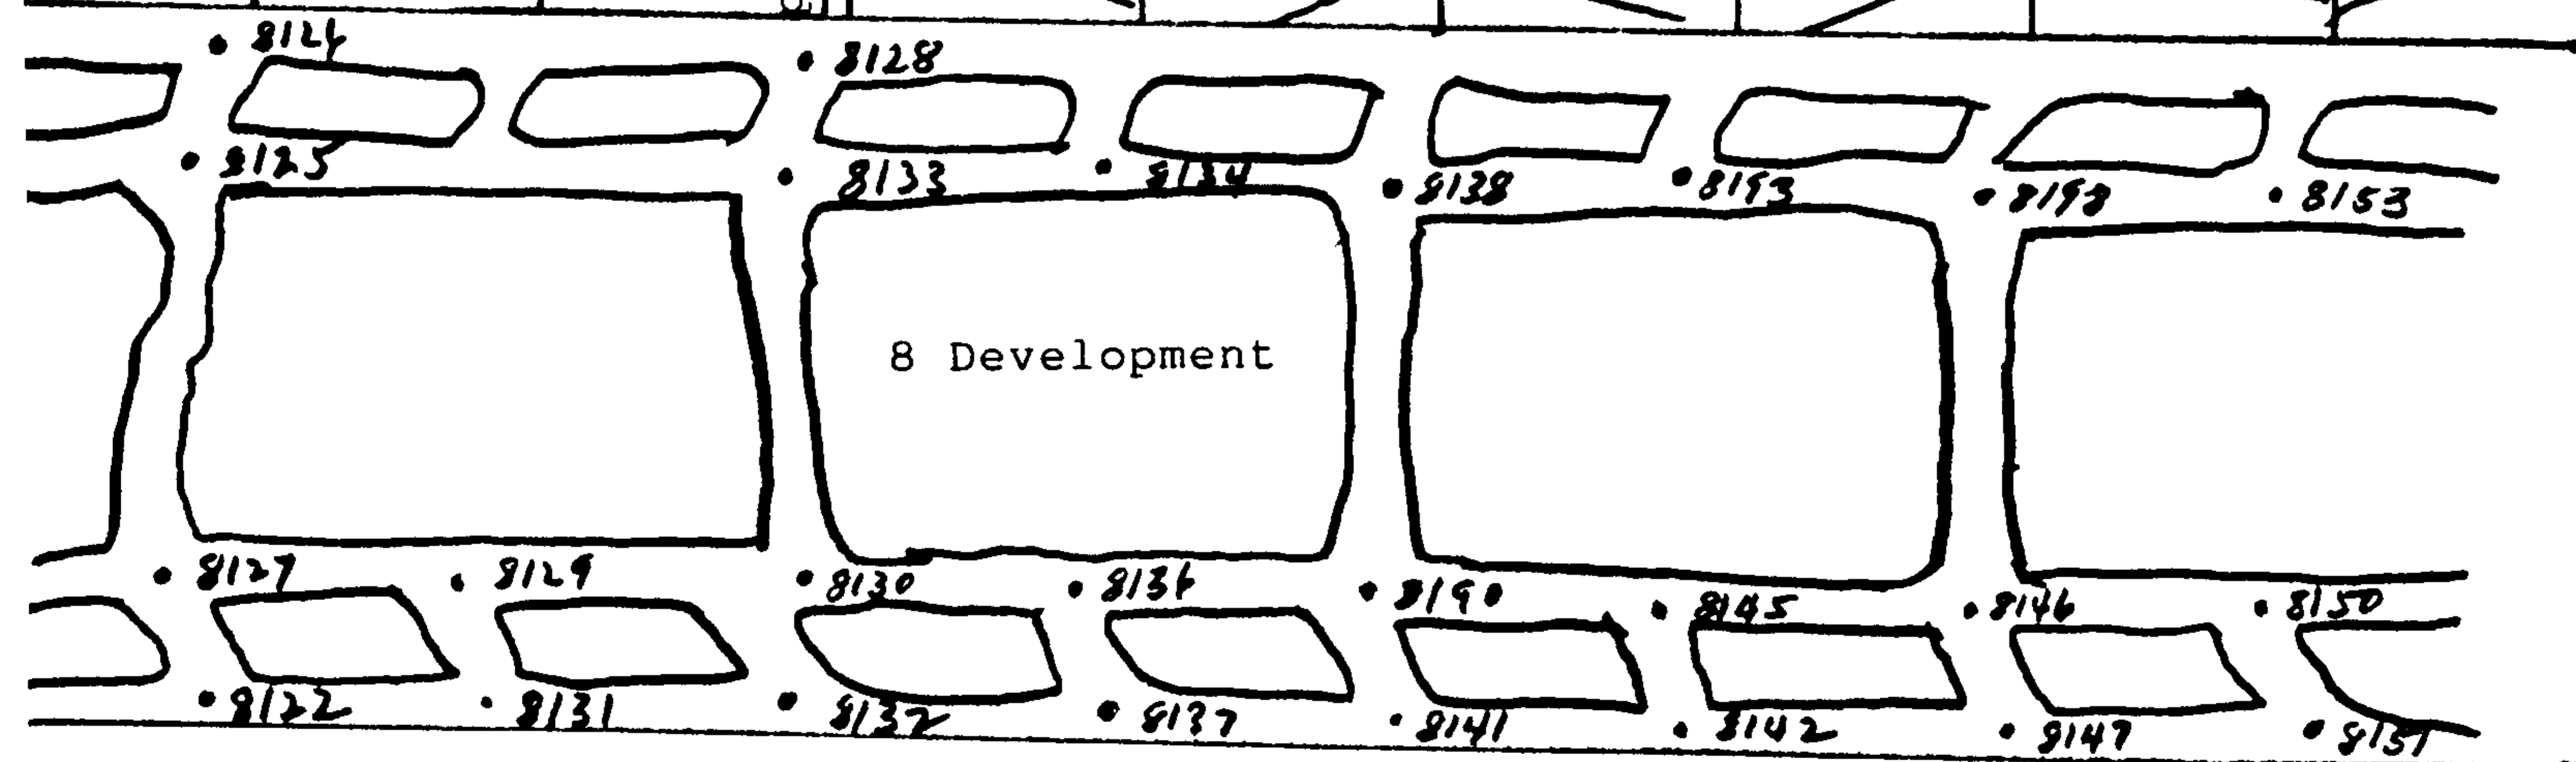
outburst location. The company has further modified development projections for longwall mining to include a load bearing pillar, 180 feet by 120 feet in dimension, in the middle of the development panel. This latest development plan is shown on the attached portion of mine map, 8 development panel.

3. At the time of the outburst, the longwall face was located approximately 20 feet in by survey station 6784. The U. S. Bureau of Mines was monitoring pressure, pillar dilation, and convergence in the No. 7 development panel entries. Research revealed that the load bearing pillars became overstressed and failed prior to the occurrence. Failure of the chain pillars resulted in additional pressures being placed on the longwall face adjacent to the tail entry. The U. S. Bureau of Mines is continuing research in the 8 development panel. Additional data is to be collected on the latest development design to evaluate performance and load bearing capacity. Such research will provide data to assist in design decisions for future development.
